CSP FY03 Milestone Report

Summary of Status of Most Promising Candidate Advanced Solar Mirrors and Absorber Materials (Testing and Development Activities)

09/30/03

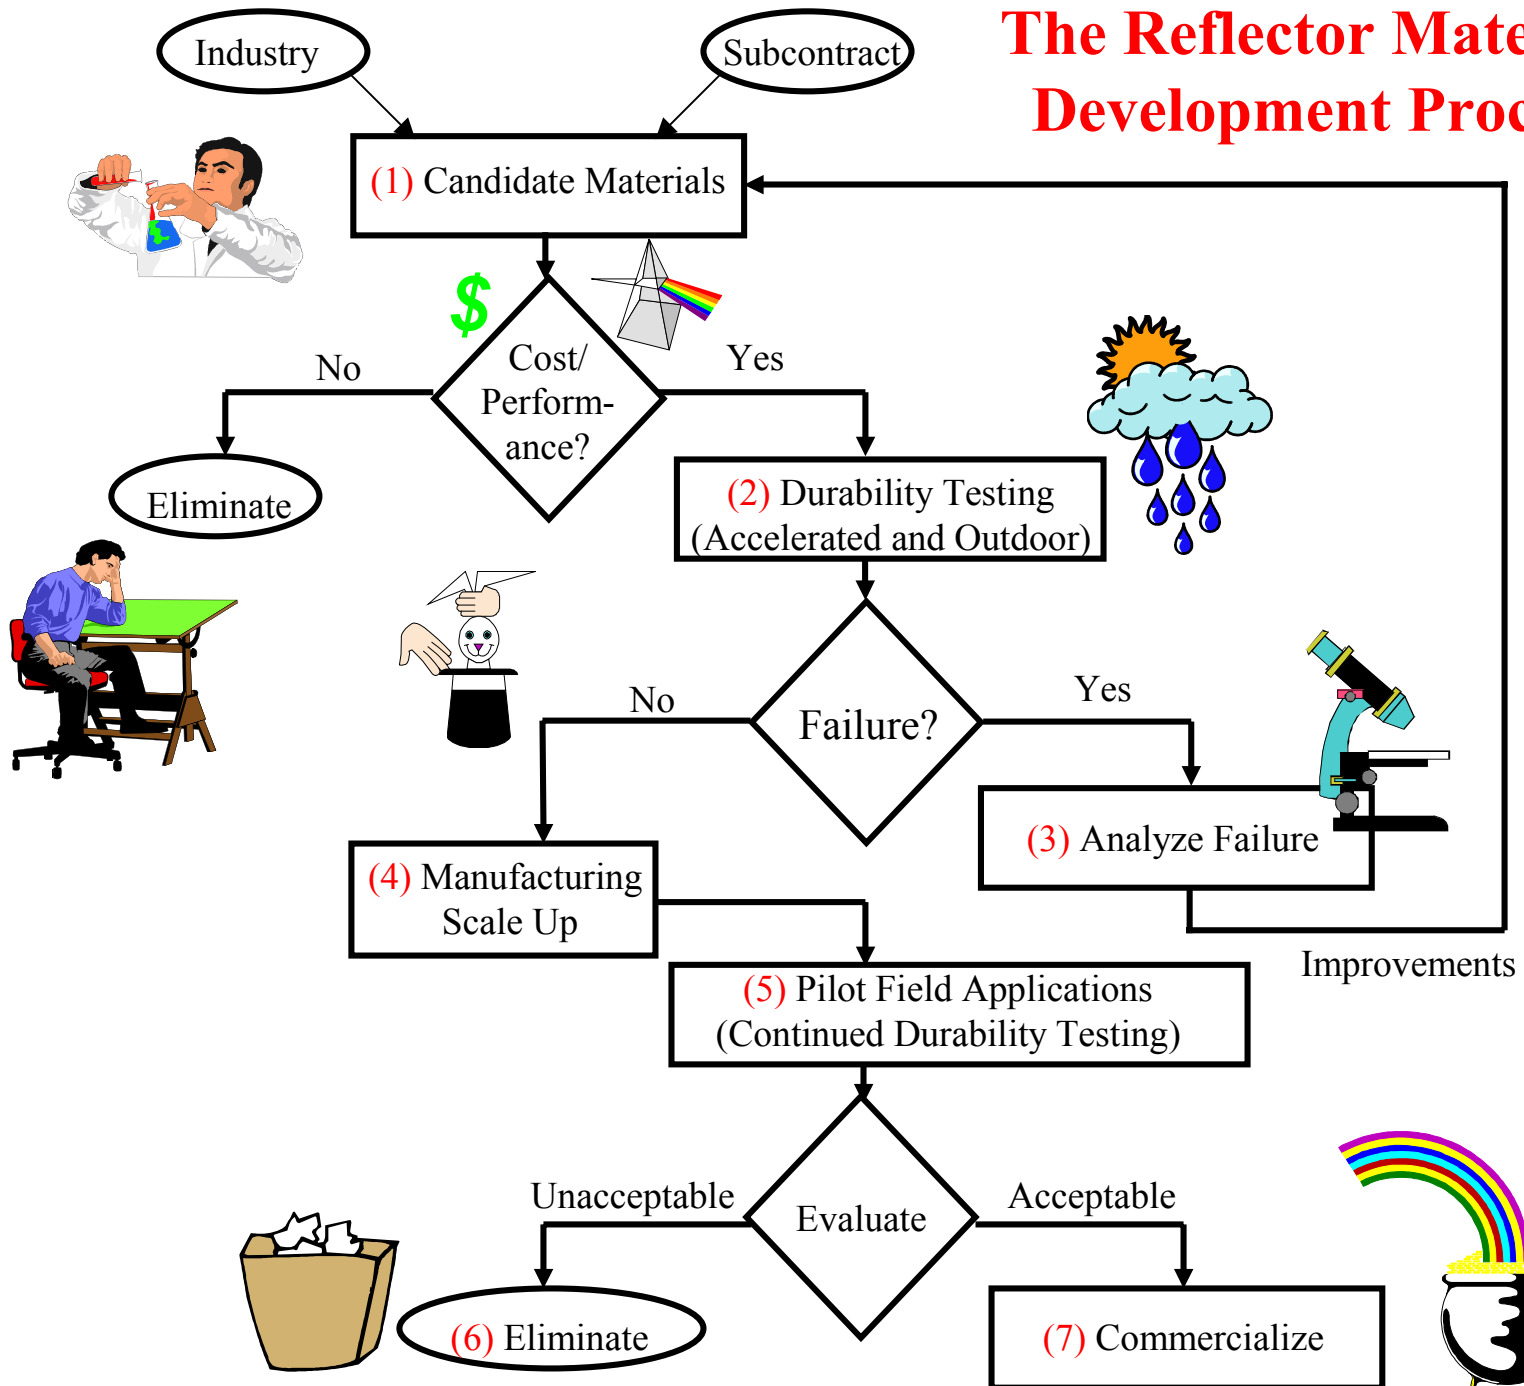
The Reflector Material Development Process

Sun♦Lab directs the development of advanced reflector and absorber materials through collaborative efforts with solar manufacturers and by interacting with the coatings industry. This allows crucial gaps in the technology to be addressed and suggestions by industry experts or from the literature to be explored. This milestone report provides an update on the status of top candidate solar reflector materials that have been identified since 1999. Candidates are categorized as being “near-term” or “longer-term”; in addition, consideration of several candidates has been discontinued for various reasons. A viewgraph approach is used to convey relevant information. One viewgraph per candidate is used. The viewgraph identifies the material, shows a diagram of the material construction, and (in bullet format) provides important aspects of where the material is in the development process; these bullets are referenced back (using numbers highlighted in red) to the figure on the following page that gives a schematic overview of the material development process from candidate conception to commercialization.

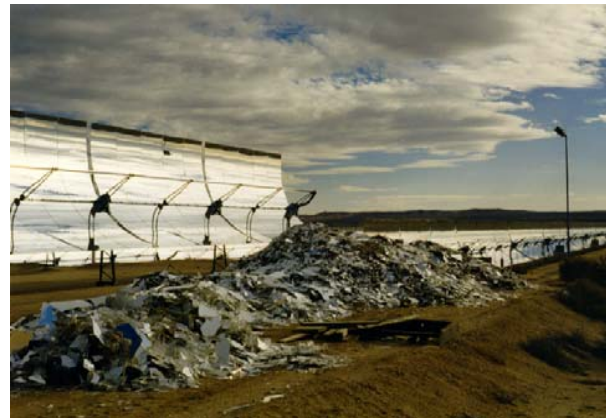
Wind Damage to Glass Mirrors

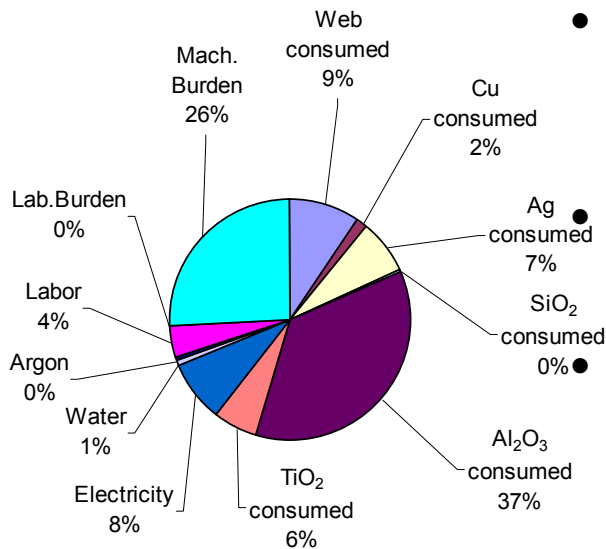
Projected breakdown of costs for super thin glass reflector (total cost = \$10.14/m²)

- Deposition rate on laboratory roll-coater doubled to 20 nm/s at end of FY02 (4); deposition conditions at 20 nm/s optimized and incorporated structural improvements in FY03 (3). Durability testing ongoing (2). New cost analysis (7) performed during FY03. Cost of reflector dependent upon substrate; alumina thickness, deposition rate, and cost; and machine burden. Material can be manufactured at ~\$1/ft² with 1 μm-thick alumina with deposition rate of 60 nm/s on PET substrate on roll-coater.

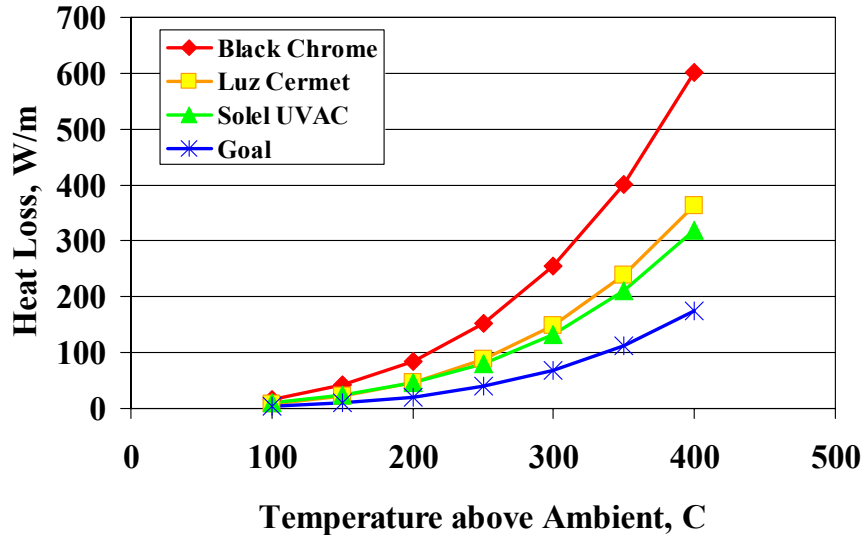
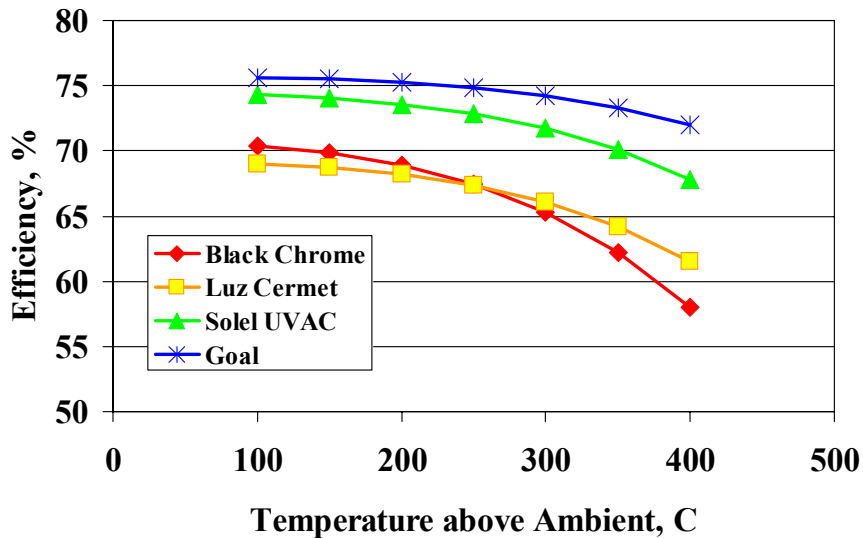
- Selective coating properties impact collector optical performance and thermal losses.
- Improvements in the receiver can significantly enhance collector efficiency.
- Coating Goals:
 - Properties ($\alpha=0.95$, $\varepsilon=0.07$ @ 400C)
 - Stable in air at 450C.
 - Improved durability of glass-to-metal-seal

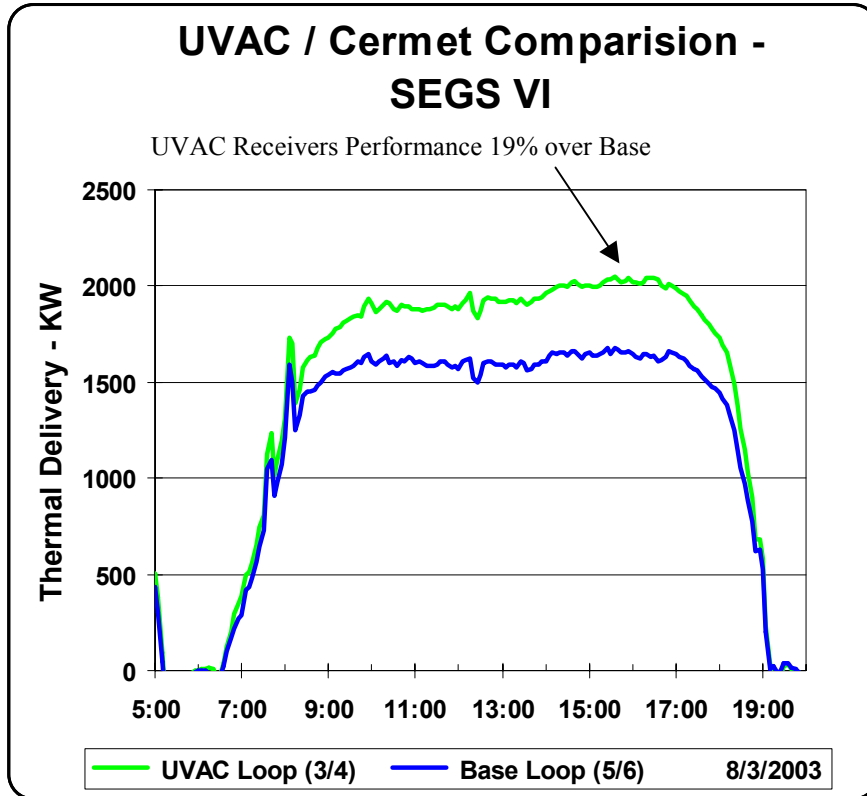
- KJCOC established baseline performance of existing Luz HCE receivers; purchased 350 Solel UVAC HCE receiver tubes; installed ~200 for performance test at SEGS VI and remainder for reliability testing at SEGS VI & VII
- KJCOC installs protective shields (IBS) over bellows after initial high failure of UVAC glass-to-metal-seals. Performance data shows >20% increase in performance of UVAC over original Luz receivers.
- KJCOC, outfitted a full LS-3 test loop with newer, 2001 batch UVACs. The test loop 33-34 A-D located at SEGS VII with insulated bellow shields and 24 Solel-designed bellow shields.
- KJCOC recalibrates flow loop instrumentation. UVAC loop continues to perform at ~20% above the original Luz receiver loop. Glass to metal seal failures were reduced when IBS installed. New UVAC bellows shields have not been validated yet.
